Lessons learned from the flood 2002 in Saxony/Germany

R. Pohl

Institute of Hydraulic Engineering and Applied Hydromechanics,
Faculty of Civil Engineering, Dresden University of Technology

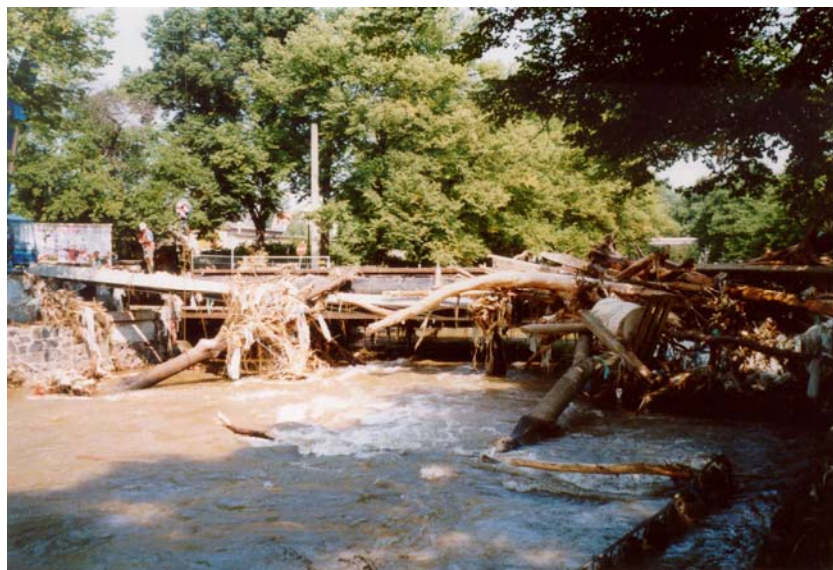
Figure 3: The Weißeritz river in Dresden after the flood event with a bridge blocked by trees and brushwoods.

Damages were caused by inundation, erosion of the river banks and building foundations, blocking debris at bridges (figure 3) and weirs. Floating trees and debris drove into houses and bridges during the high level flood.

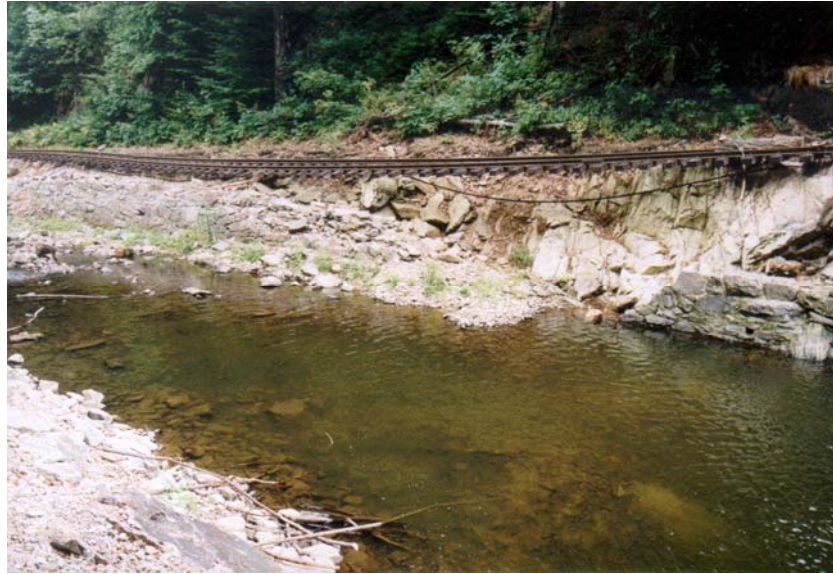
Figure 4: The Weißeritz river after the flood event with the destroyed railway line on the right bank (flow direction is from the right hand side to the left hand side).

Due to inundation of the entire valley bottom, significant debris was deposited over a large area. Embankments roads and railways were washed away (figure 4). The rapid flow eroded roads and footways, and damaged drinking water, gas, electrical mains and sewers. In addition, foundations of buildings were destroyed.

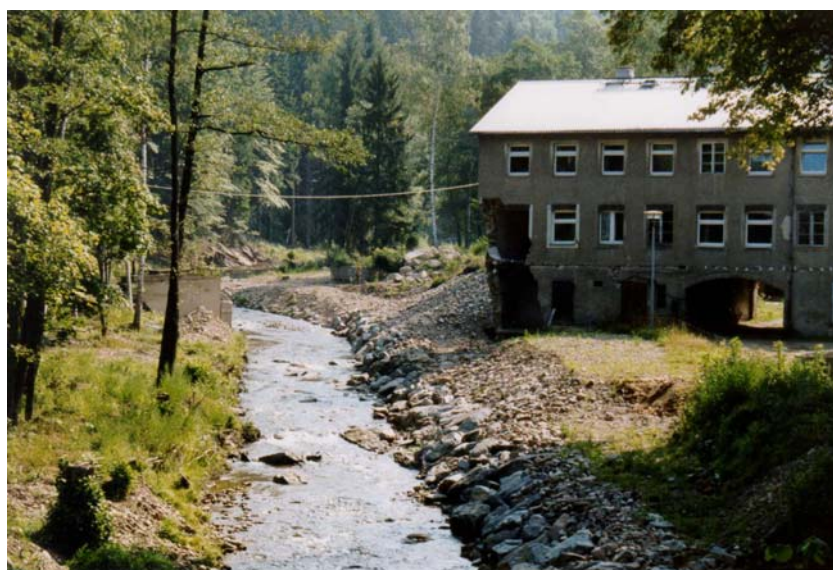
Figure 5: The Müglitz river after the flood event. On the left bank the abutment of a destroyed road bridge is to be seen. The corner of the house standing close to the right river bank was washed away.

Immediately after the event a mapping exercise was compiled of the flood damage. For the most part urban areas were affected by inundation (figure 2) due to their location in the natural floodplain. In this area houses were, and, still are situated very close to the river banks and therefore the backwater effects increased water levels. Damage to property close to the river bank was clearly greater to property standing further away, as Figure 5 shows.

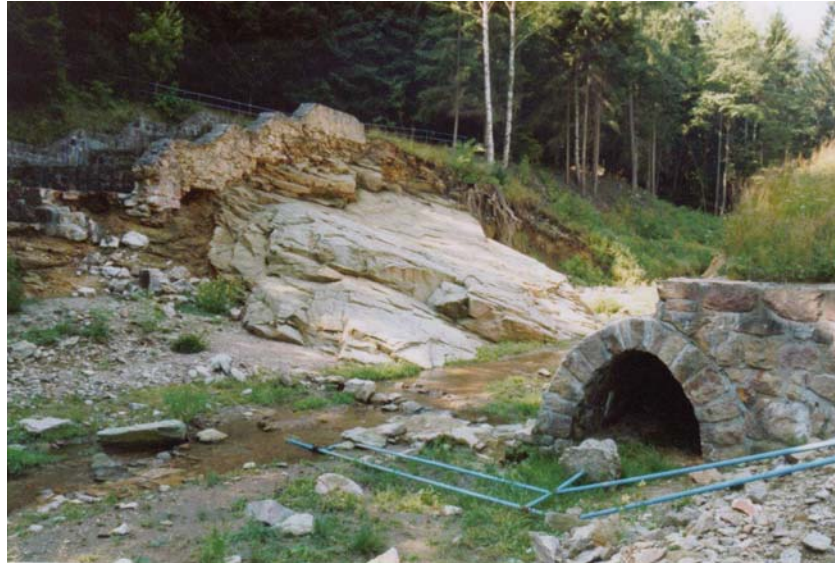
Figure 9: Broken section of the Glashütte/Briesnitz dam from downstream in August 2002. On the right hand side (in flow direction) the ruins of the stepped spillway are visible and right in the foreground there is the downstream end of the outlet tunnel.

The earthfill dam with a straight dam axis had a height of 9 m. The upstream and downstream faces of the dam were covered with grass. No sealing existed in the upstream dam fill and no drainage present in the downstream dam toe.

On the southern end of the dam a stepped spillway existed which had a capacity of about $5 \text{ m}^3/\text{s}$ just when the water level reached the dam crest. At Glashütte the Briesnitz river flows partly through a small rectangular channel and partly in an underground tunnel. This is the reason for why the discharge through the outlet tunnel was reduced to $7 \text{ m}^3/\text{s}$, in order to protect the downstream town.

The cause of the dam failure is given in very detail by *Bornschein & Pohl (2003)*. Due to the extreme rainfall event, the basin was filled and at the end the dam was overtopped. The overtopping lasted about 3 and a half hours until dam crest erosion began. Dam fill material was eroded in form of big clods, which were instantaneously transported downstream. Within half an hour the breach reached

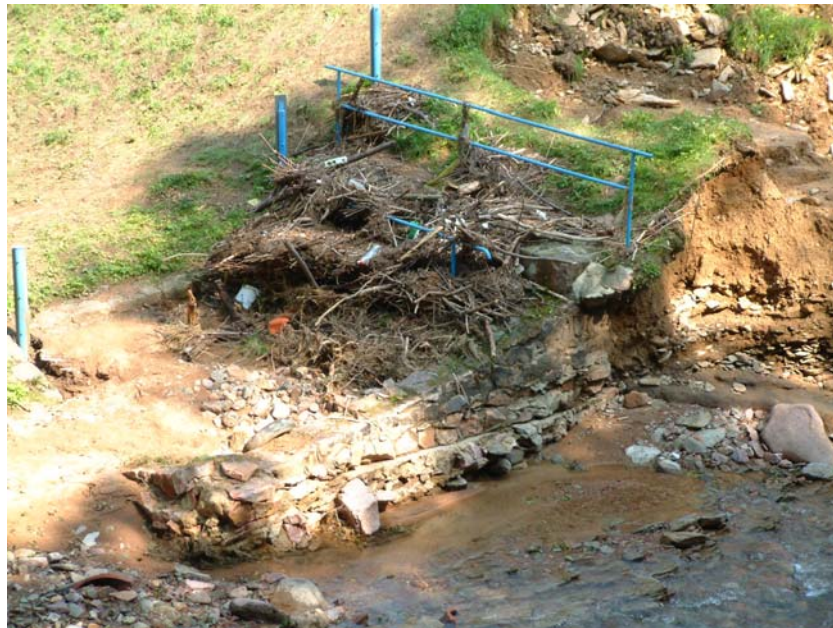
Figure 11: Upstream entrance of the bottom outlet tunnel after the flood event. It was totally blocked with brush-wood and rubbish.

The relative small impact of the dam break on the Müglitz valley caused partly by the relatively small storage volume of the retention basin and partly by the extreme flood due to the rainfall event. However contributory factors of the Glashütte dam break included the insufficient dimensioning of the spillway and freebord. The situation was exasperated by the downstream outlet being congested with brush-wood, trees and rubbish (figure 11).

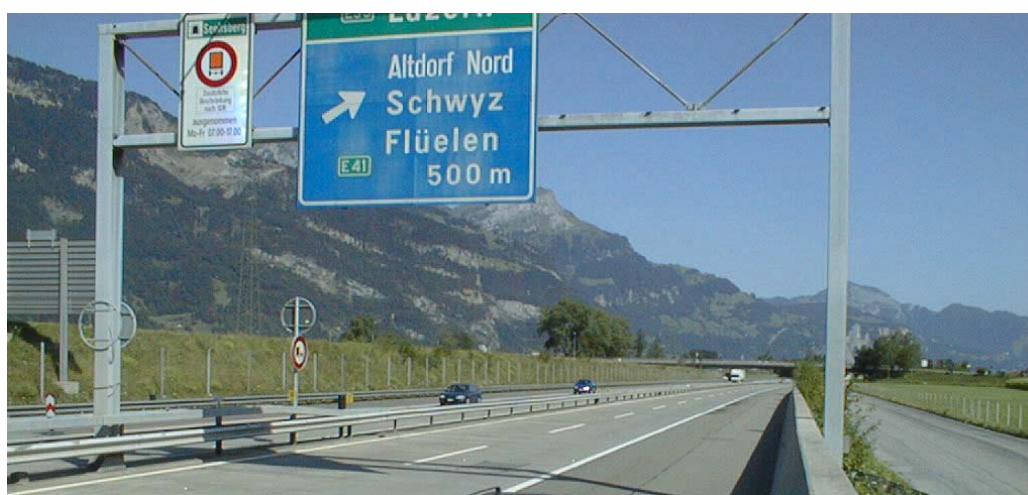
Figure 13: The St.-Gotthard motorway as a flood channel of the river Reuss in Switzerland. On the right side there is a flood protection wall.

Another proposal is to use streets as flood-bypass-channels. The authors have proposed this for a smaller stream in Dresden. There is already such a project realized: In Switzerland the St. Gotthard Motorway on the northern side of the alps can work as a bypass (figure 13). Other proposals are flood tunnels under a city or fuse plug weirs to give way when floods occur. Also bypass tunnels in the way of large sewers have been proposed for several towns in Saxony such as Pirna (on the Elbe), Glashütte (on Müglitz and Briesnitz) and Grimma (at the Mulde river).
